PTRO Review

Type: Byway Open to All Traffic (BOAT) & Restricted Byway (RB)

Name: Cottered RB 020 & Cottered BOAT 047

Location: Cottered

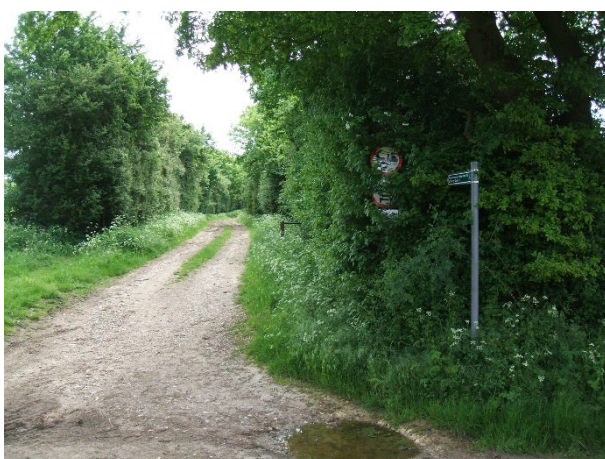
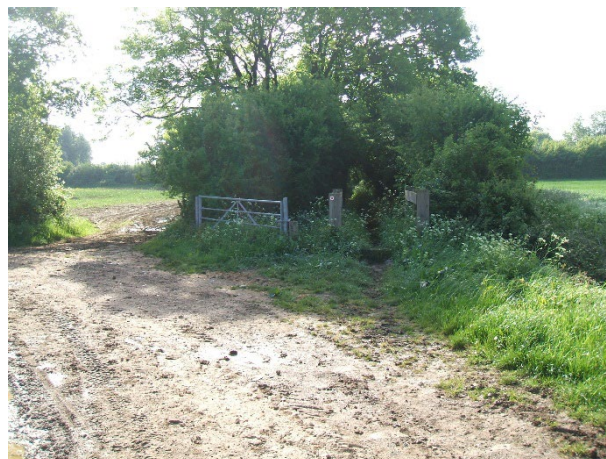
RB 20 is concurrent with a farm track, good granular compacted surface used as a farm access track.

A gap and barrier allow access for walkers, cyclist and equestrians, excludes parallel axle motorised traffic at the junction with BOAT 47.

The route of BOAT 47 is unsuitable as parallel axel motor vehicle could not pass without causing damage and the soft natural surface is immediately adjacent to the Old Bourne water course (EA controlled).

The path surface is subject to a high clay content soil and is prone to winter poaching at current levels of equestrian use. This reduces its load bearing capacity in relation motor vehicular use. Little opportunity exists for drainage improvements in this area without compromising the natural vegetative margin of the water course concurrent with the public right of way.

The natural grassy surface has evidence of vegetation and a worn trod line that shows use by cycle, horse, and foot traffic.

Barrier allows walkers, cycle and equestrian access, potential motorbike access through this gap.
